# **Lightning and Surge Protection of Photovoltaic Installations**

## **Two Case Histories: Vulcano and Kythnos**

François D. Martzloff

**June 1989**

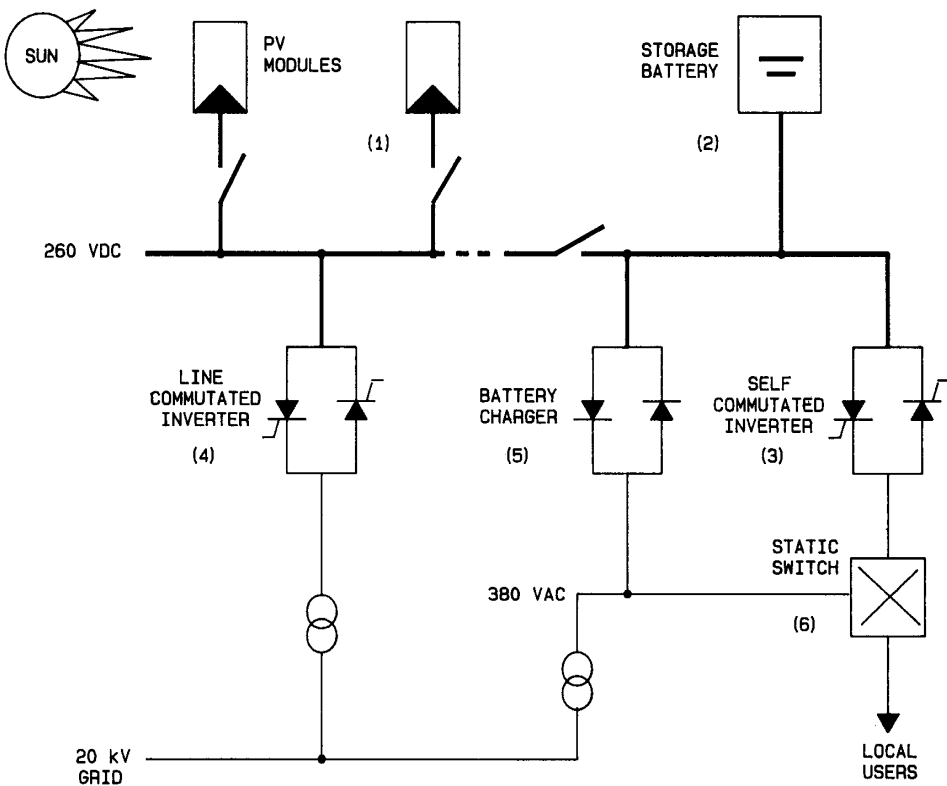
Figure 2-1. Block diagram of the Vulcano photovoltaic system

The Vulcano photovoltaic system (see Figure 2-1) includes the following major components: the array (1); a storage battery (2); one self-commutated, stand-alone inverter (3); one line-commutated inverter (4); a rectifier for charging the battery (5); and a static switch (6). More complete system diagrams by ENEL are given in Appendix A [1].

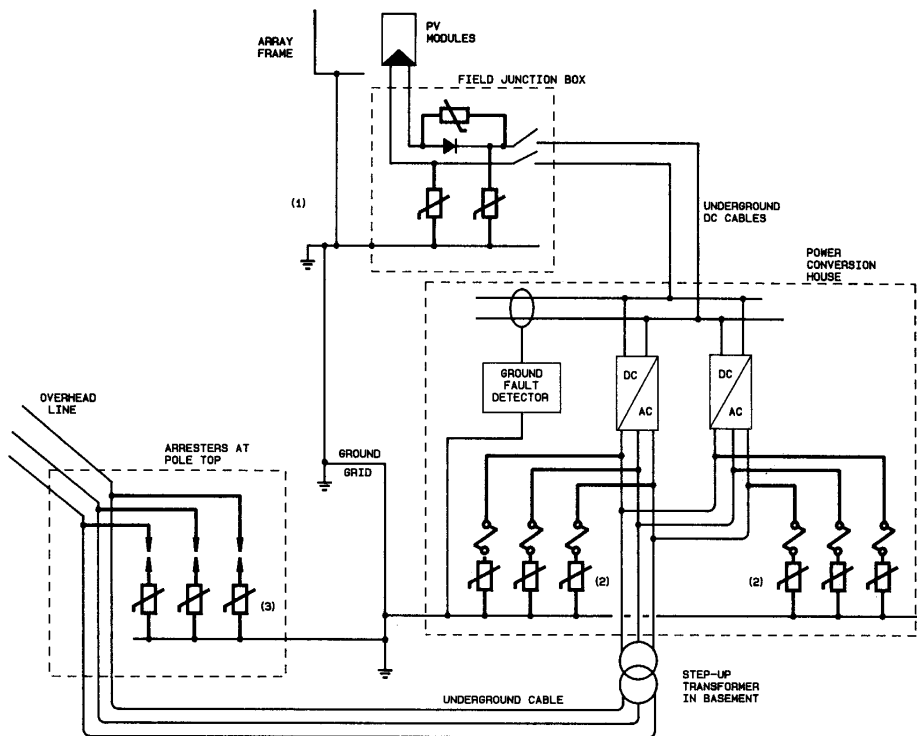
Figure 2-2. Surge protective devices at system interfaces

In the Vulcano system, the dc system is not grounded. A ground fault detection system is provided (Figure 2-2), with alarm indication on the control panel (Photograph 2-3) but no automatic trip nor remote indication of the fault condition (the system is unattended). Experience with this system is described as satisfactory after an initial period of reported difficulties associated with insulation deficiencies in the panels. (These were eventually corrected by field or factory rework on the panels.)

Overvoltage protection for the Vulcano system is provided at three interfaces, as sketched in Figure 2-2:

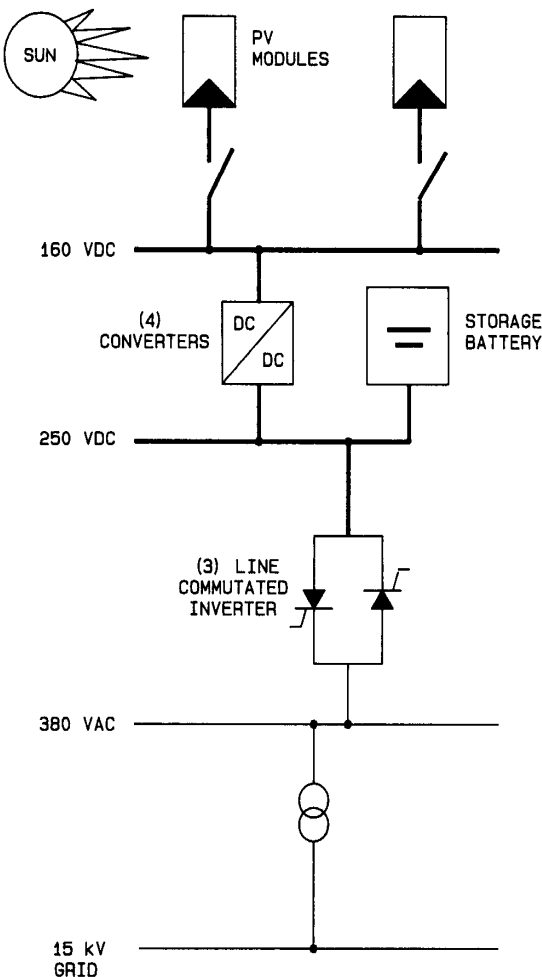
Figure 3-1. Block diagram of the Kythnos photovoltaic system

Several panel failures have occurred in 1986, 1987, and 1988, which have been attributed to lightning. Lightning rods and surge arresters are provided at this site, making it an interesting subject of study, both for an explanation of the presumed direct strikes occurring in spite of the lightning rods, and for a study of the protection afforded by the surge protective devices installed in the circuits, as well as their failure modes. Further information on the history of panel damage is included in Appendix B.

The installation was designed and implemented by Siemens, as one of the experimental facilities coordinated by the European Economic Community (Photograph 3-1). The plant has a nominal output capacity of 100 kW. Figure 3-1 shows a schematic of the system components. The modules are grouped in arrays formed by a series string of 20 modules, each producing a dc bus voltage of 160 V. Each of these 43 arrays is terminated in a junction box in the field, where two or three strings are connected in parallel to bring the dc power to the power conversion cabin (Photograph 3-2).

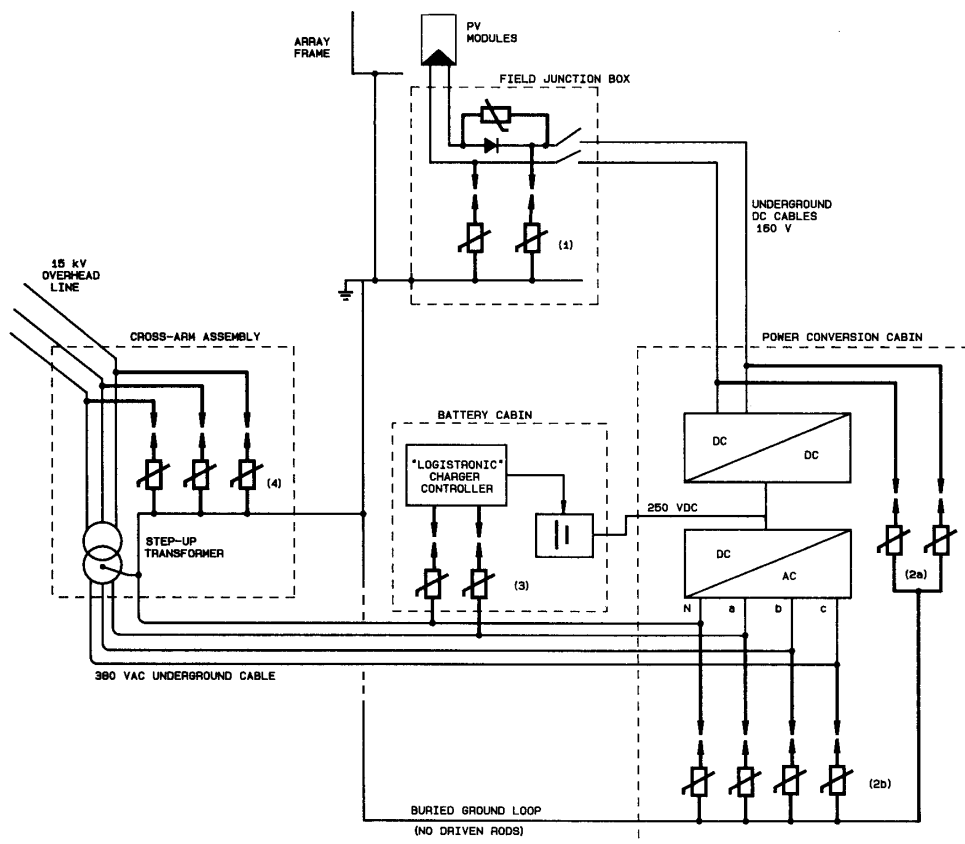
Figure 3-3. Overvoltage protection at system interfaces

Overvoltage protection at the Kythnos installation is provided at four interfaces, numbered (1) through (4) in Figure 3-3:

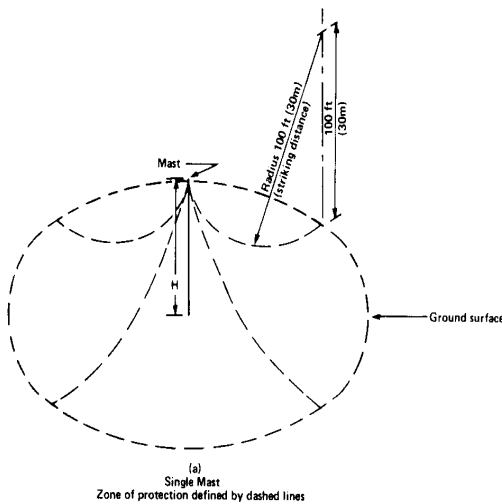
Figure 3-5. Rolling ball criterion  
(Source: Reference [5])

Considering now the configuration of a vertical mast on the ground plane (Figure 3-5), rolling a ball on the ground until it touches the tip of the ball defines the limiting condition when the descending leader will terminate at the tip of the mast, thus leaving other points below the sphere uninvolved. Figure 3-6 shows
